BHI-01384
Rev. 0

105-B Reactor Museum Feasibility Assessment (Phase II) Project

**Prepared for Bechtel Hanford, Inc.,
by MACTEC, Inc.**

June 2000

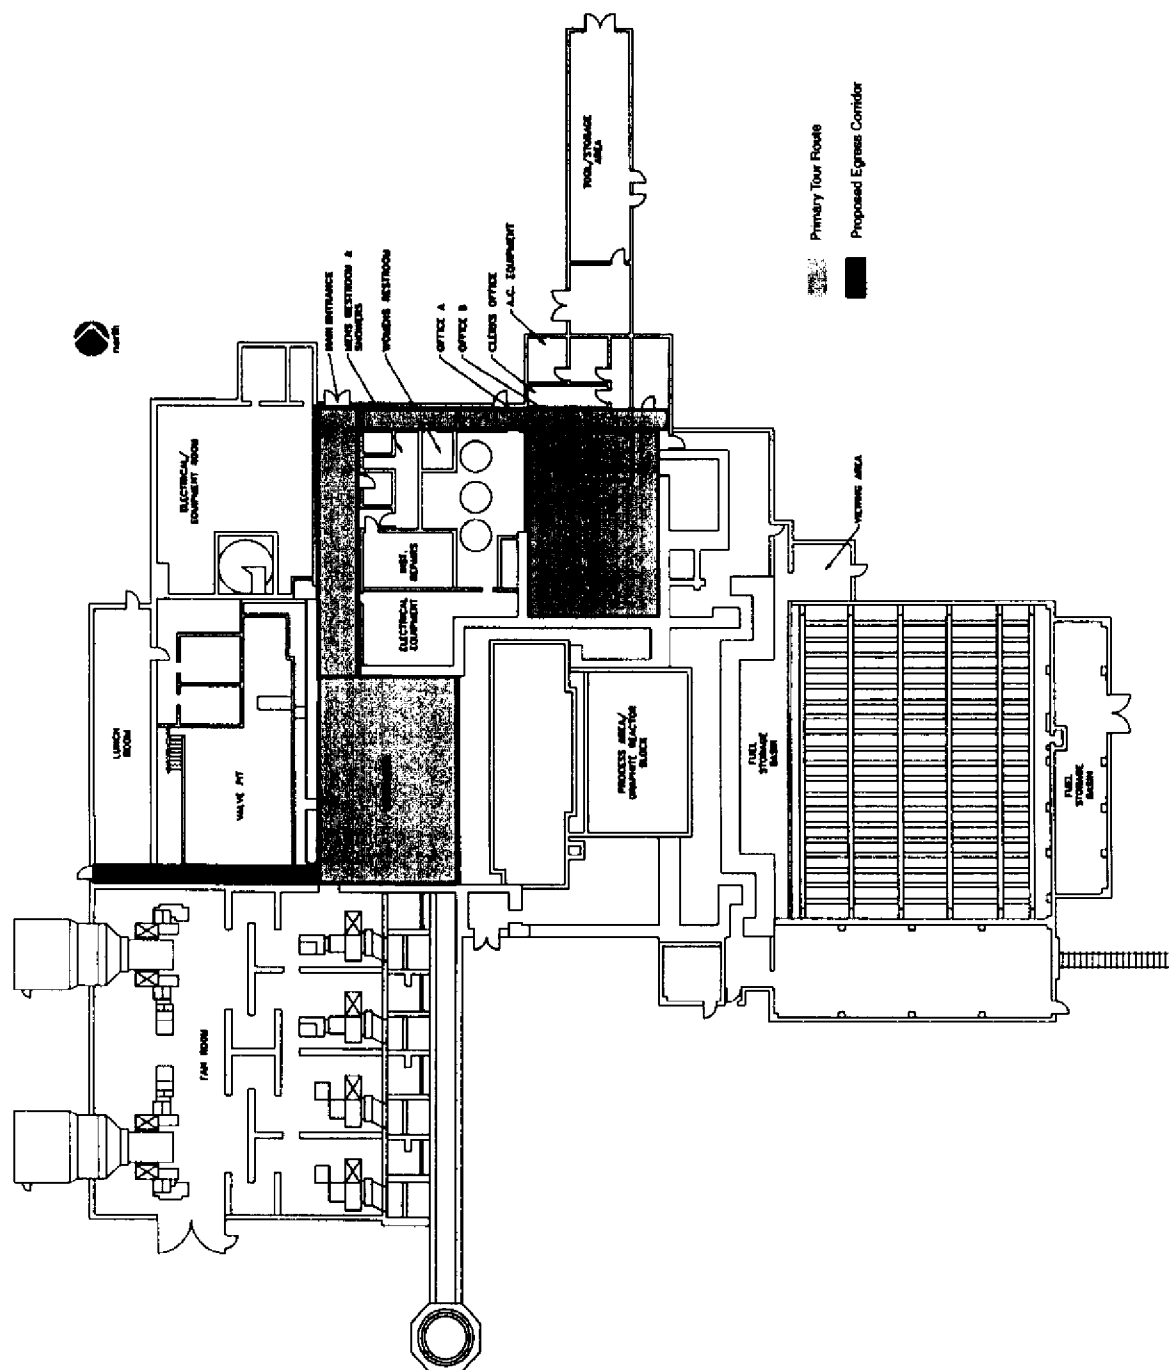
Figure 2-2. 105-B Reactor Building Floor Plan.

To mitigate hazards and correct deficiencies associated with building egress, an additional exit path is proposed out of the front-face work area through the south end of the valve pit room (Figures 2-2 and 4-3). This exit path is routed through areas located outside the primary tour route. The existing steel sliding door at the southwest corner of the work area or southeast corner of the valve pit room (in the center of Figure 4-3) shall be permanently fixed in the open position. Access will, therefore, be allowed into an egress corridor that exits through the south end of the valve pit area. This egress corridor shall extend from the opening where the sliding door now exists, through the valve pit area, along a grated walkway at the south end of the room, through the door at the southwest corner of the valve pit area (Figure 4-4) into the lunch room, and finally through the exterior door (Figure 4-5) at the southwest corner of the lunch room. The lunch room door leading from the valve pit, in addition to the steel sliding door, will be permanently fixed open to provide for the egress corridor. Providing for this egress corridor will require modifications to the grating on the walkway in the valve pit area. Steel-plate material will be installed over the existing grating to provide a solid surface. Ramps or other suitable transitions will be installed to accommodate differences in elevation between the concrete floors and the walkway grating. The existing handrails will be modified to prevent falling between railings. Barriers shall be provided to restrict access to other portions of the valve pit area and lunch room. Modifications to handrails and new barriers will be separate or otherwise clearly distinguishable from existing components and will not detract from the appearance of those components.

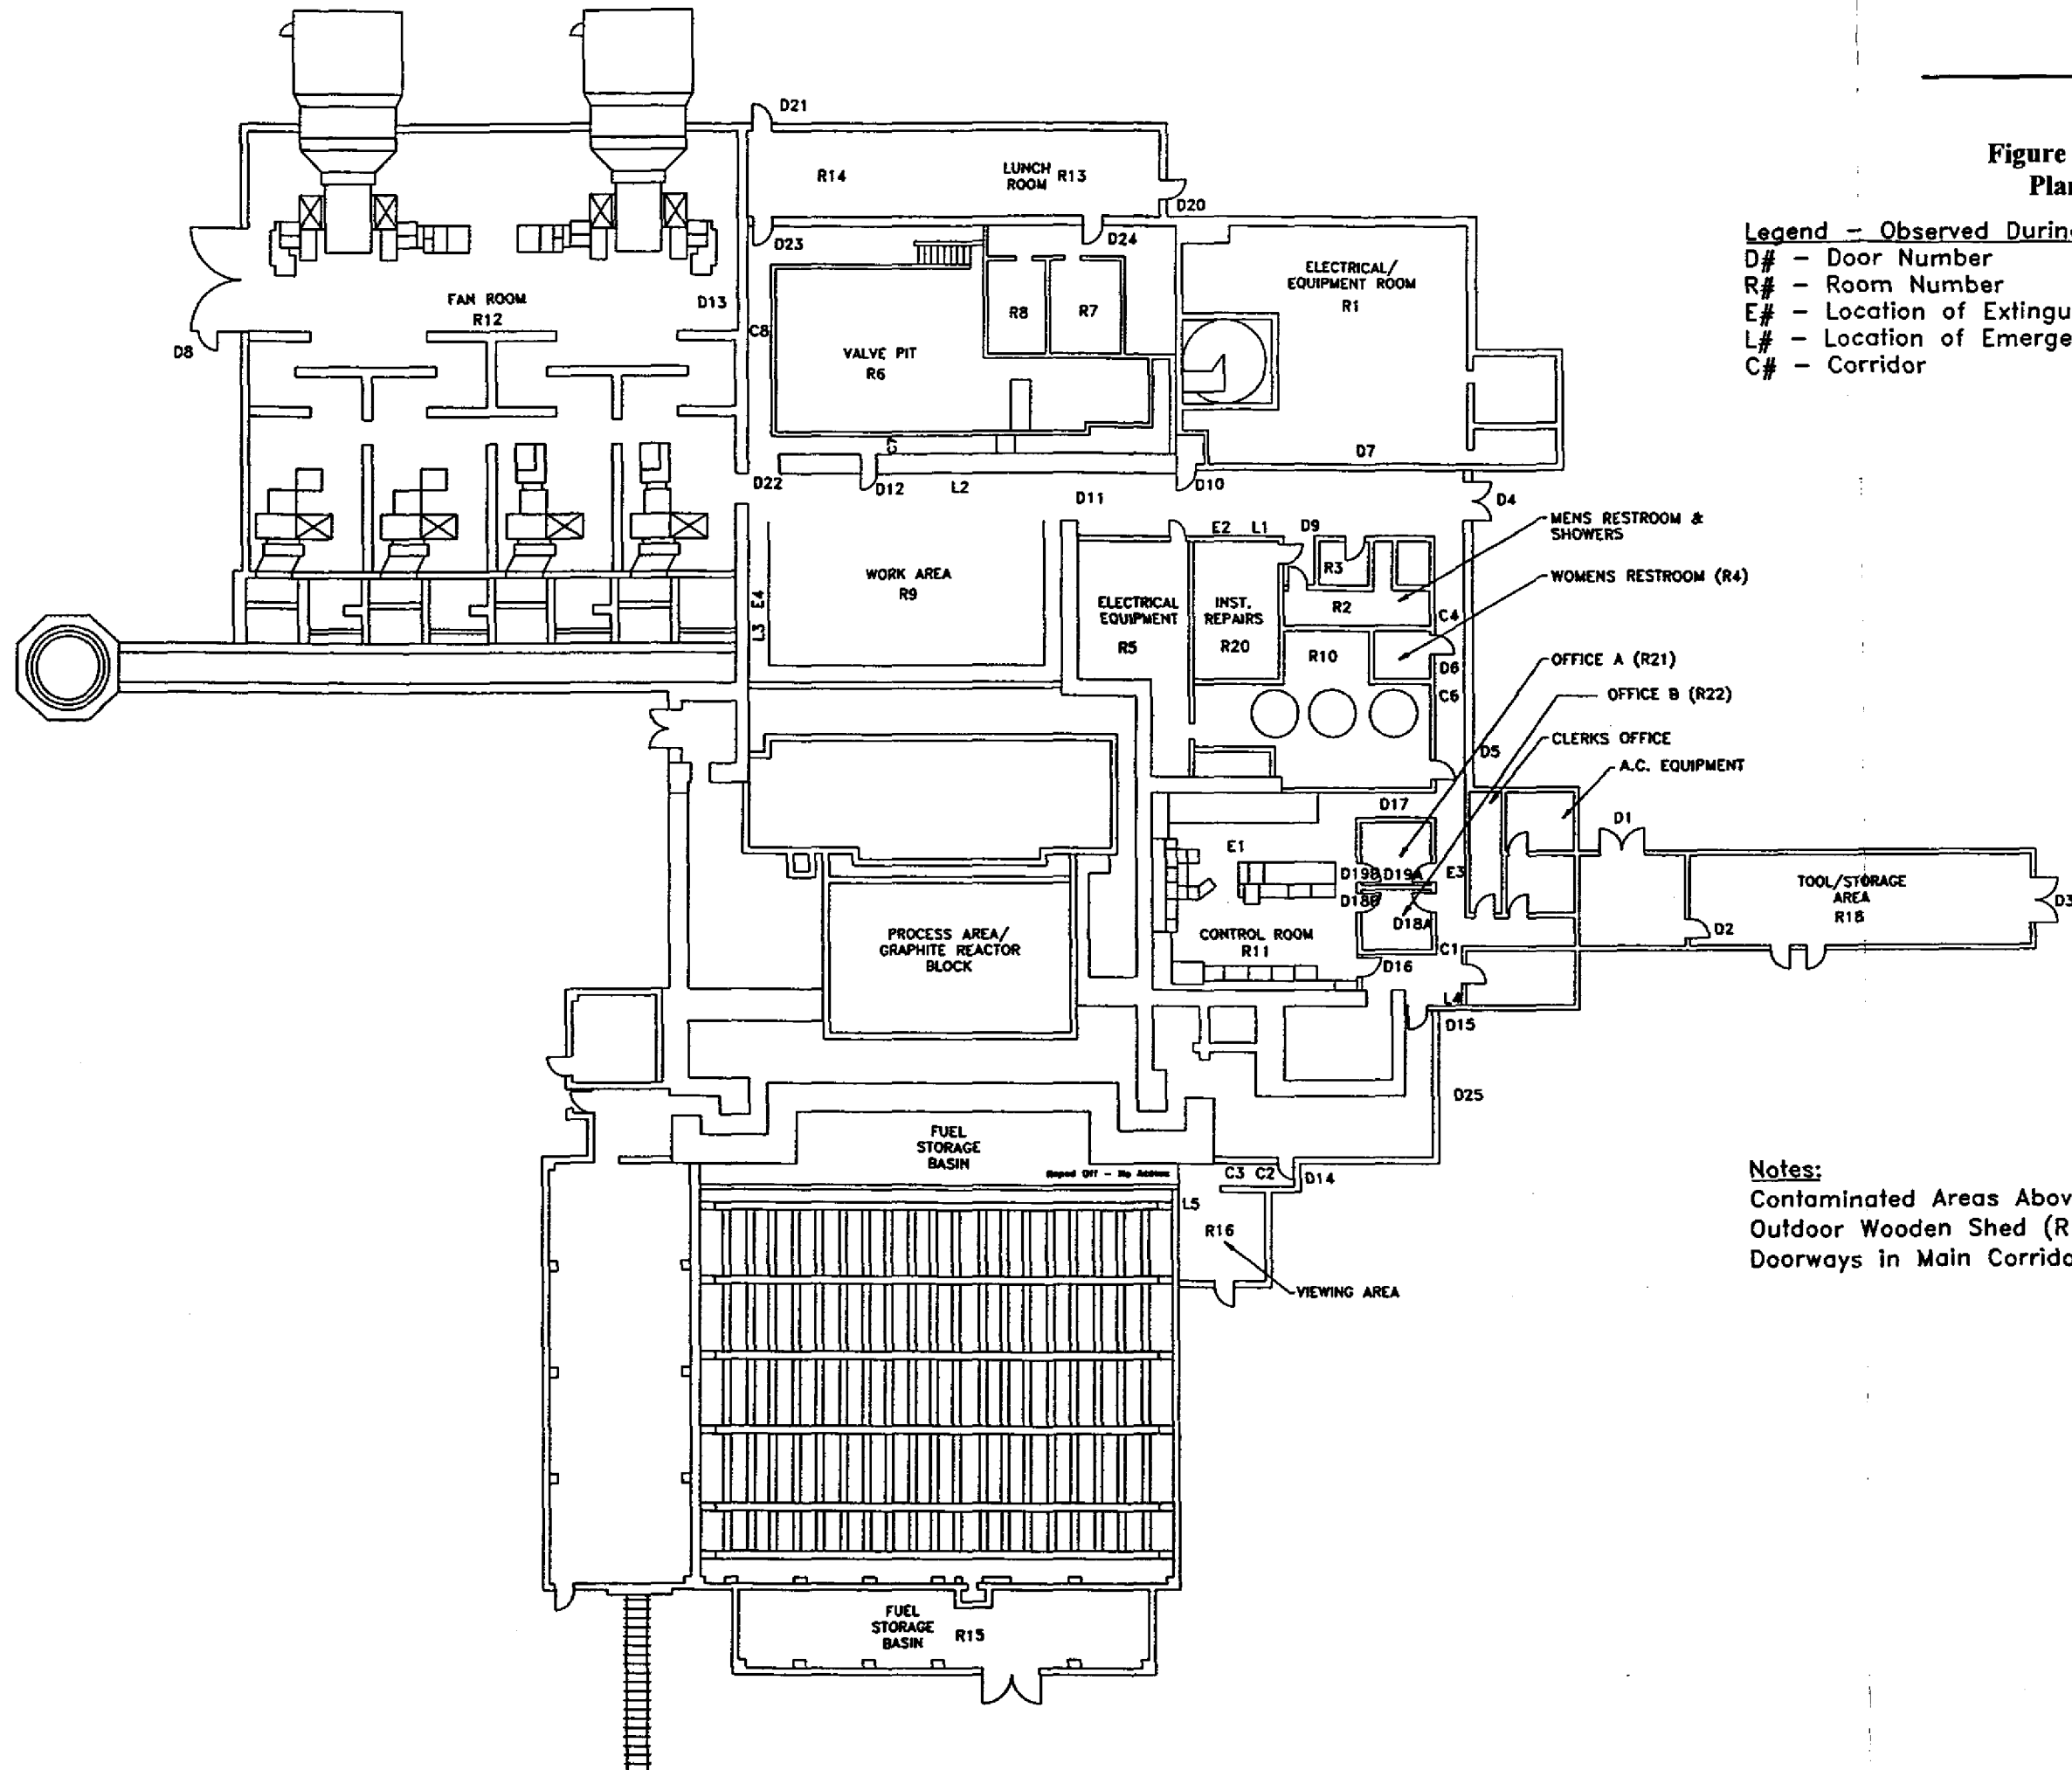
Contaminated Areas Above Ground Level (R17)
Outdoor Wooden Shed (R19)
Doorways in Main Corridor (C6)

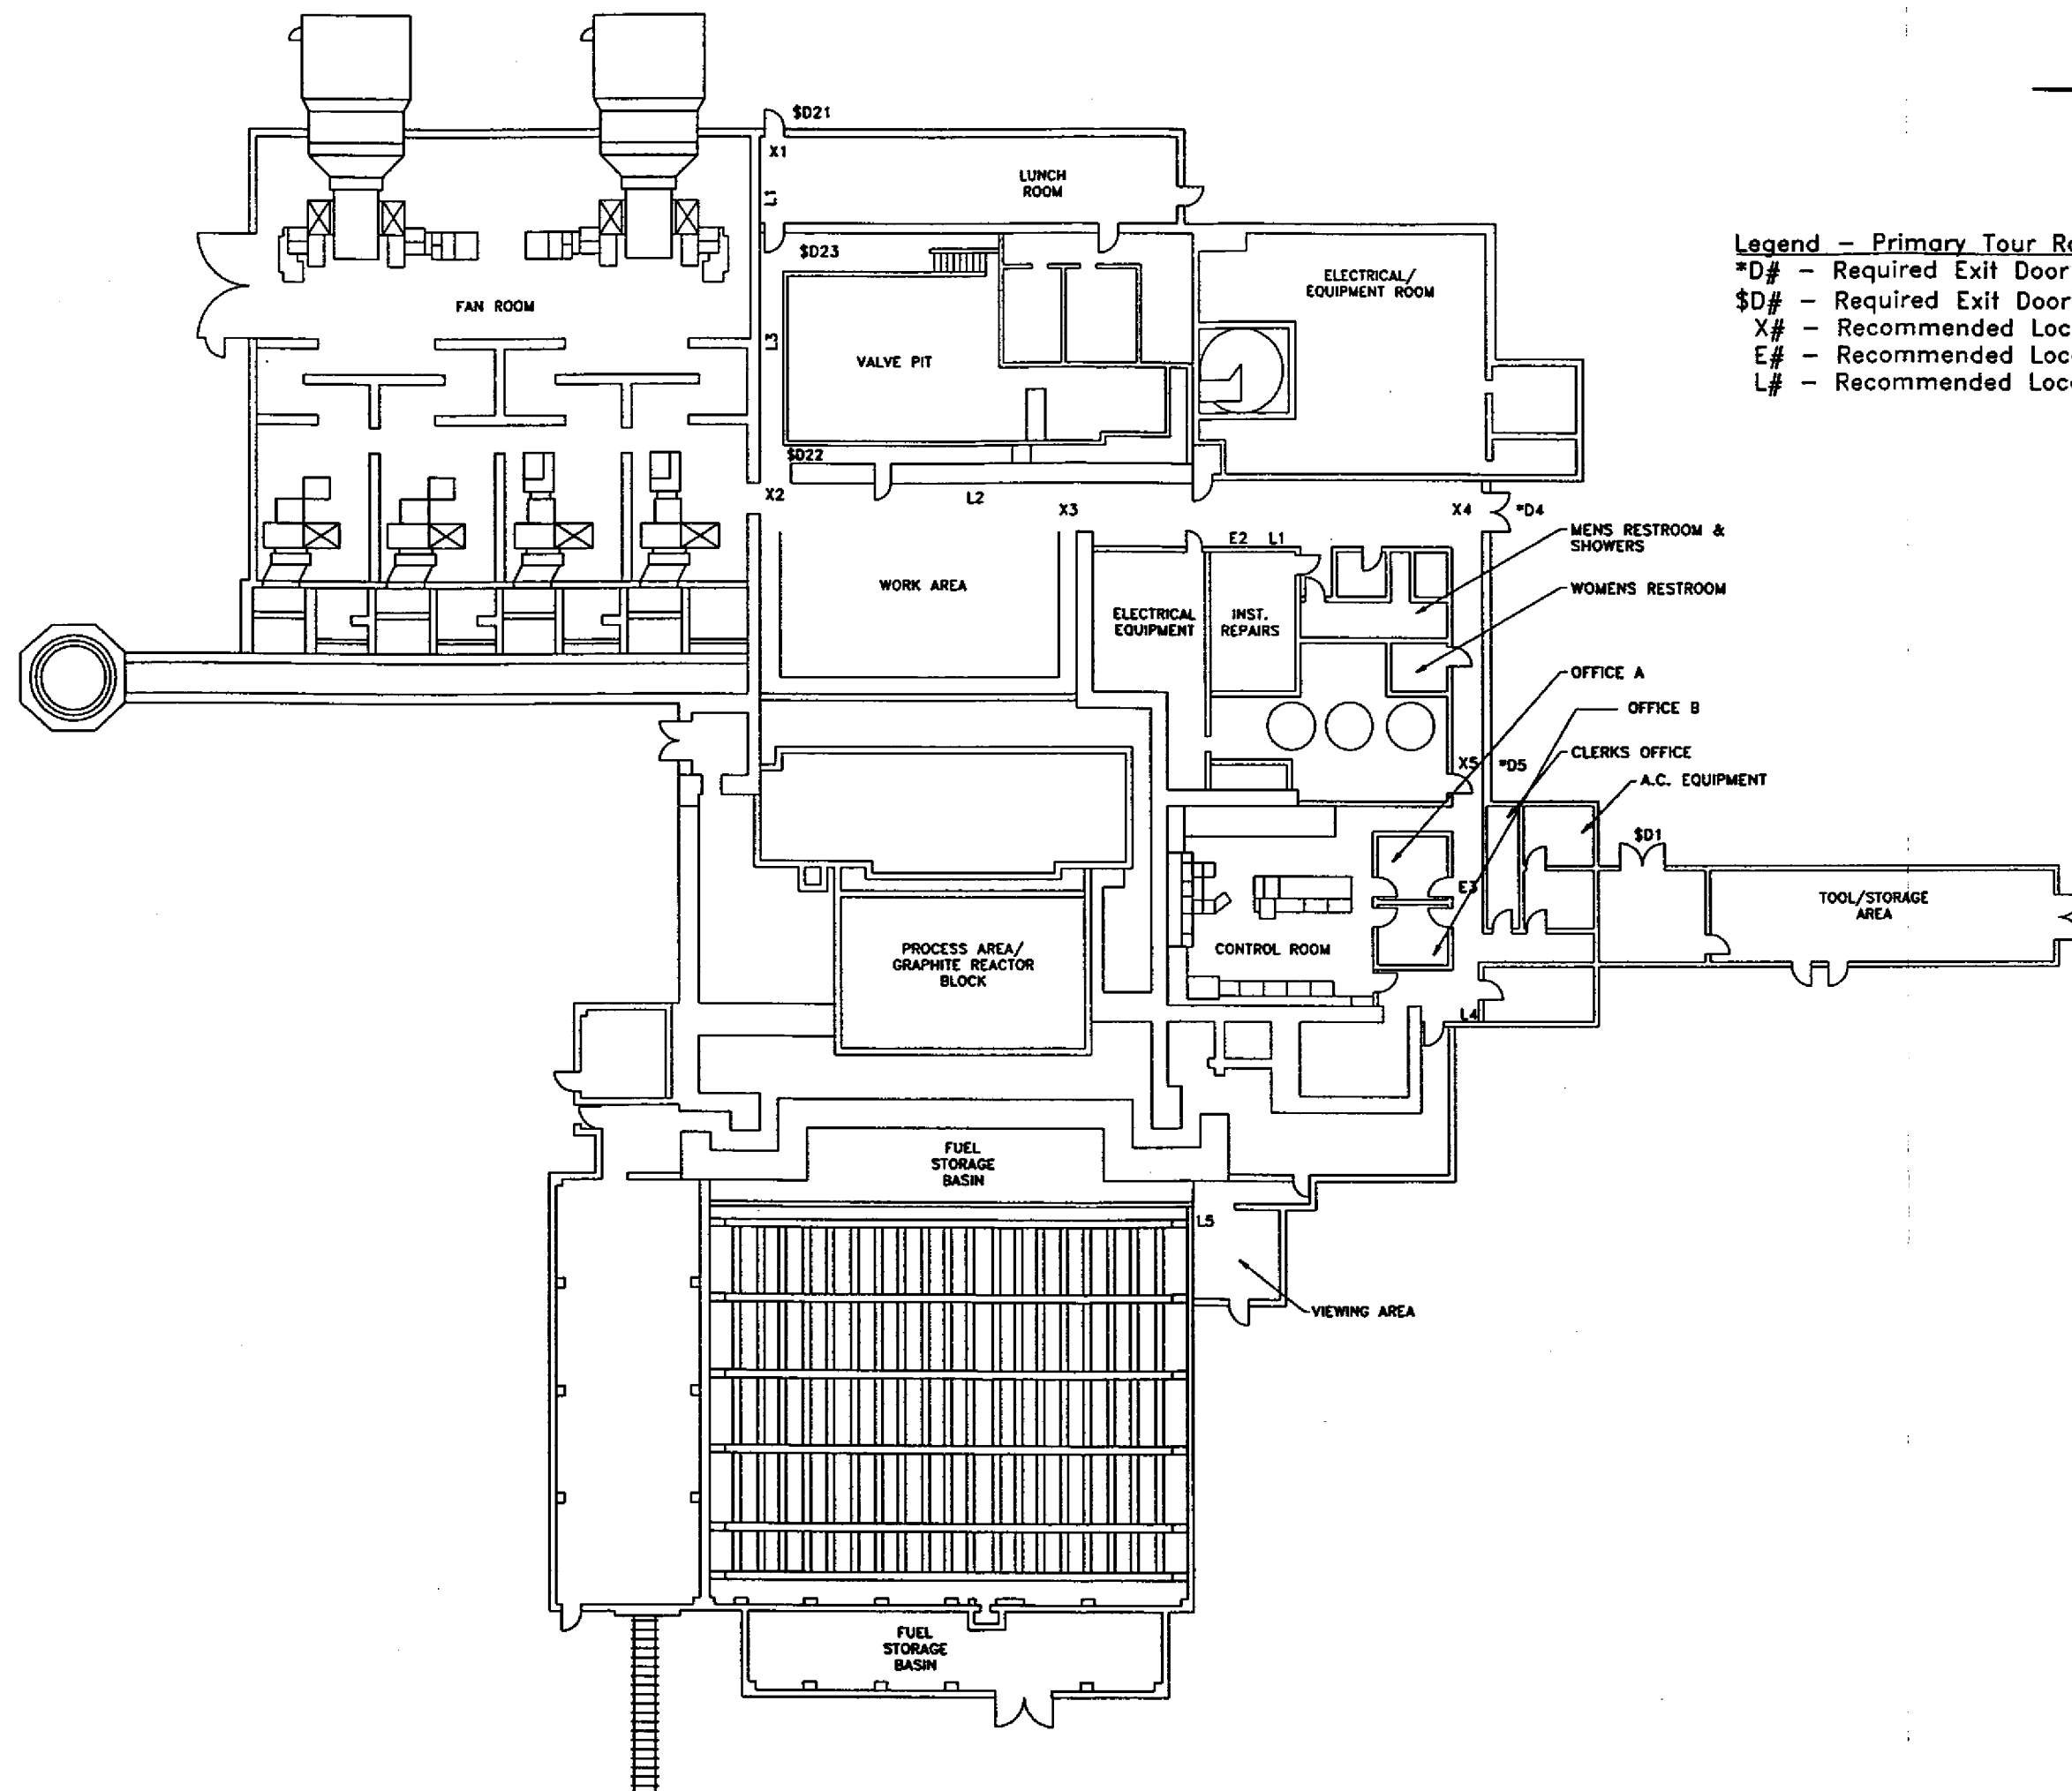
Figure C-2. 105-B Reactor
Floor Plan.

- Panic hardware – Doors that are provided with a latch or lock are required to be provided with panic hardware in accordance with Section 8-2.2.2.3 of NFPA 101. Doors D5, D20, and D21 are provided with panic hardware, the condition of this equipment shall be inspected to ensure that these devices are operable and comply with NFPA 101, Section 5-2.1.7 (see Section C.19.9).

- Door conditions – Doors throughout the facility shall be inspected to verify their condition. Damaged equipment observed during the walk-throughs include doorknobs that were difficult to turn or were slightly damaged, door closers that were damaged or broken, and glass panes that were missing (see Section C.19.9).
- Fire-resistant corridors – Section 8-3.6 of NFPA 101 requires corridors to be rated one-hour fire resistant, when used as an exit access, serving an area with an occupant load of 30 or greater. Currently these requirements are not met (see Section C.19.9).
